# Manhole Inspection Summary

Manhole # S33I\_\_022MH

Insp Date: **3/26/08 1:32 PM**

**Location** Address: **100 lombard**

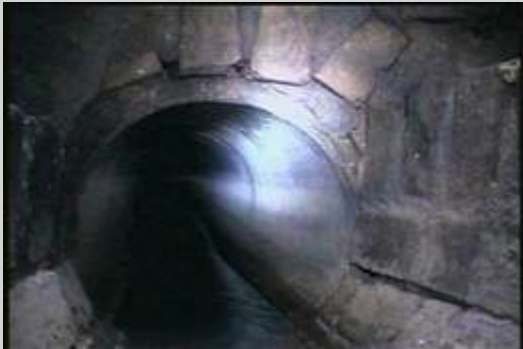
12 O'Clock Outflow

10 in. Circular Gravity Sewer  
Pipe Out @ 12 O'Clock

Deposits: ☒ None ☐ Mud ☐ Sludge ☐ Debris ☐ Grease

Infiltration: **None** Pipe Seal Cond: **Unknown**

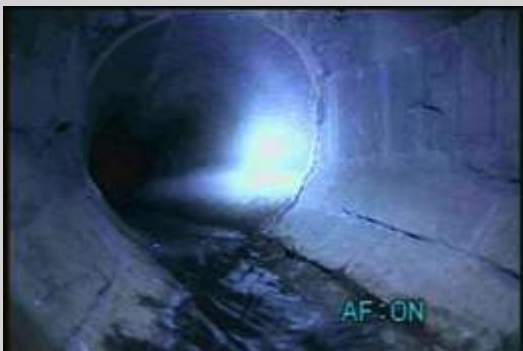
4 O'Clock Inflow

10 in. Circular Gravity Sewer  
Pipe In @ 4 O'Clock

Infiltration: **None** Pipe Seal Cond: **Unknown**
